Datadoc - DEC/VAX 7xx0/10xx0

This section by Dave Bazley.....

Revision: Written July 1993, updated January 1994, August 1994, April 1995.

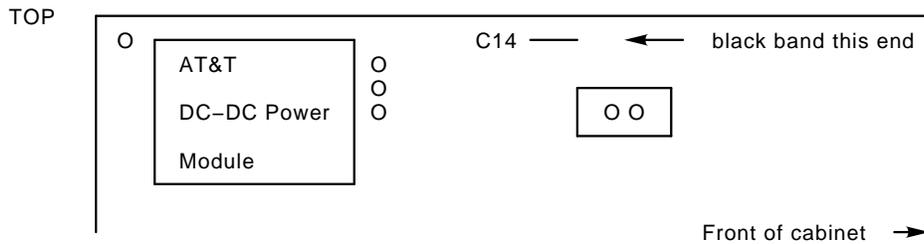
A bunch of systems left AYR between WK21 and WK31 of 1994 with capacitor C14 on the CCL module reversed. Most of these systems have been traced by DECnumber, so I mention it here just in case one or two slip through and cause subsequent problems. When the capacitor fails it will prevent the system from powering up. Thus it's failure will only show up when the system is next powered down! Now fixed by FCO 7xxx-F005 (see Section 13).

This is the correct orientation of C14:
