**DECsystem 5100**  
**PrestoServe/NVRAM Option Information**

Order Number EK-NVRAM-OM-001

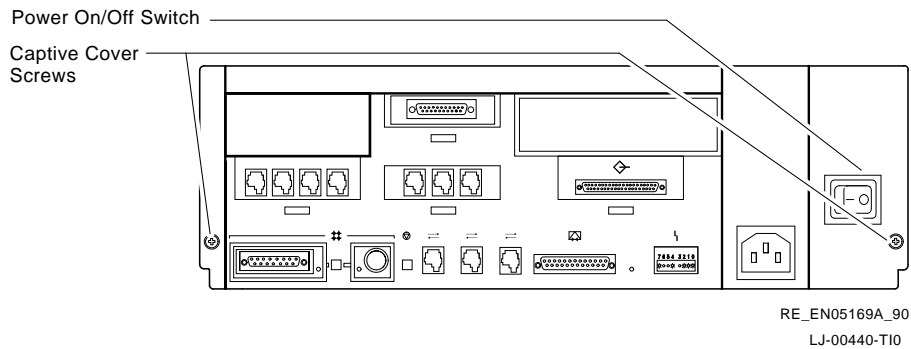
**Figure 2-1 Location of On/Off Switch and Cover Screws**

1. Remove the system unit cover by performing the following steps:
  - a. Turn the system power off (O). See Figure 2-1.
  - b. Label and disconnect all the cables connected to the system unit.
  - c. Loosen the two captive cover screws on the back panel of the system unit (Figure 2-1).
  - d. Slide the cover forward, and up from the system unit.

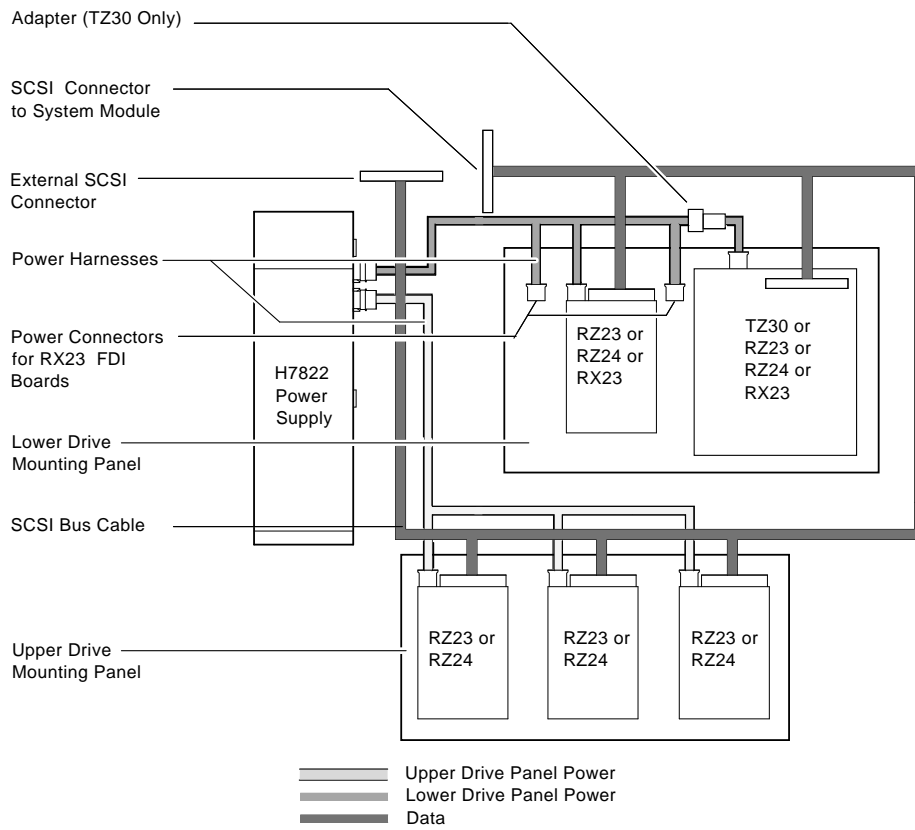
Figure 2-2 Drive Mounting Panel Power and Signal Cabling

- a. Disconnect the power harnesses from the H7822 power supply and disconnect the SCSI bus cable from the drives on the upper drive mounting panel (Figure 2-2).
- b. Unscrew the four captive screws (Figure 2-3).
- c. Lift the upper drive mounting panel from the lower drive mounting panel and gently set it aside.
- d. Note the position of the metal partition, then remove it from the lower drive mounting panel.

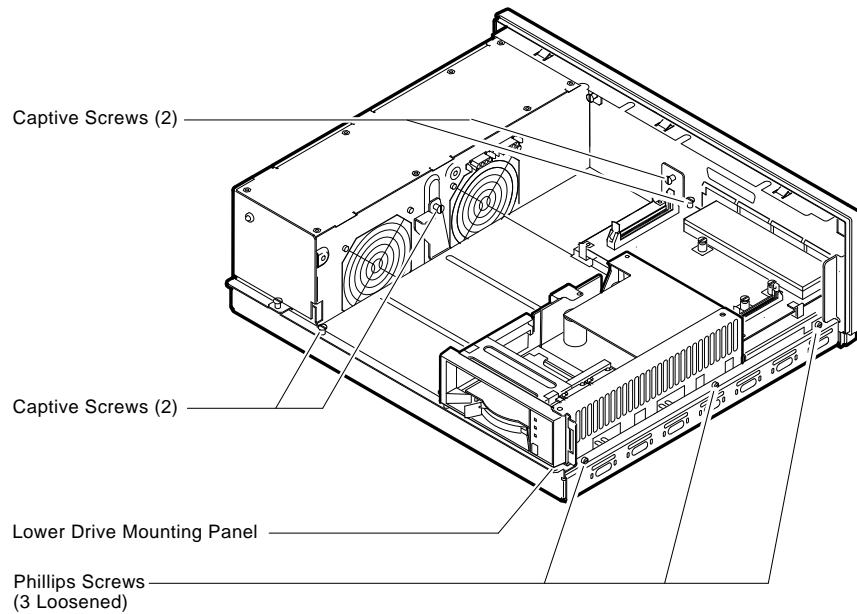
Figure 2-4 Releasing the Lower Drive Mounting Panel

- Unscrew the four captive screws and remove the three Phillips screws on the left side of the unit (Figure 2-4). Store the screws in a safe place.
- Slide the panel forward (with the devices attached), then lift the panel from the system unit and gently set it aside.

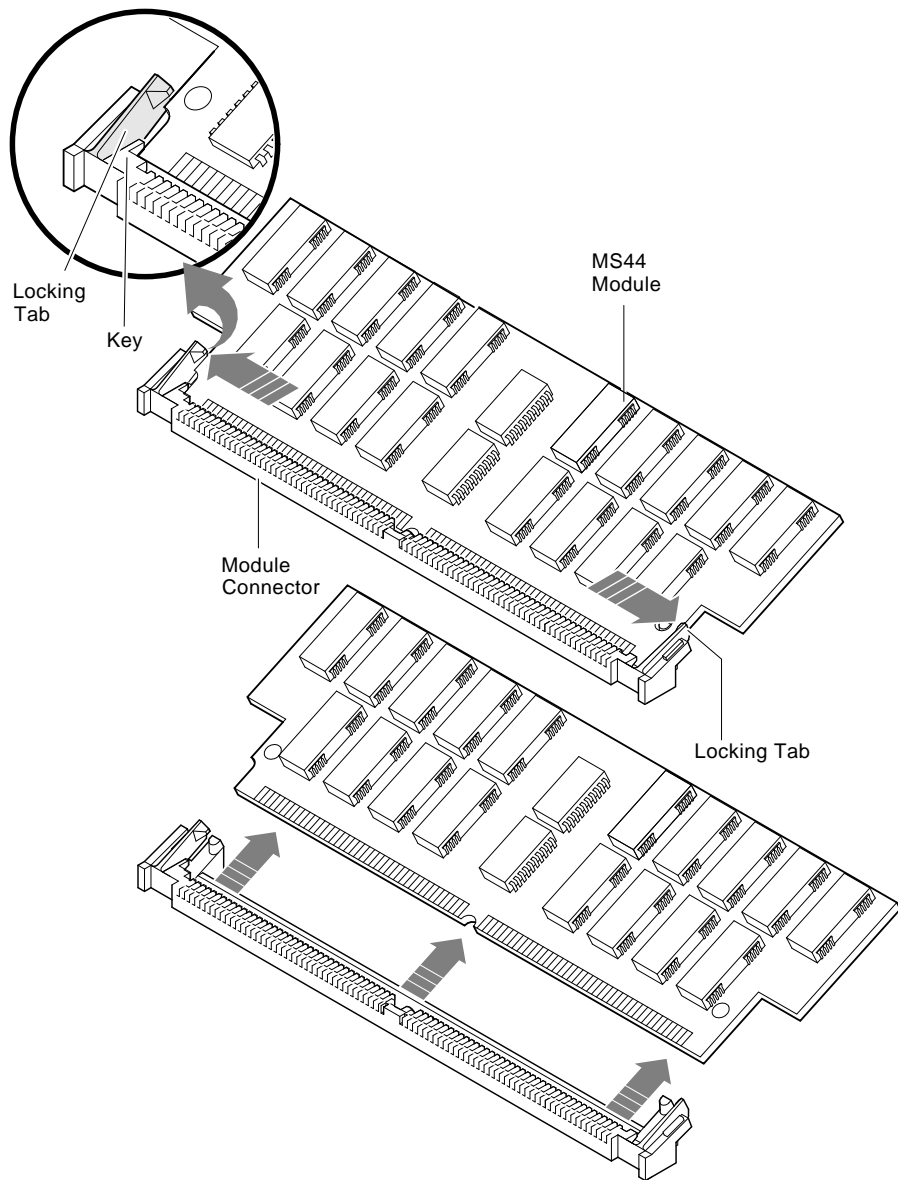
Figure 2-5 Removing NVRAM Module

**To remove MS44 memory modules ensure that the two locking tabs are disengaged, otherwise damage to the connectors will occur. You must remove the modules contained in the highest available banks first, in order to access the locking tabs of the other memory modules (Figure 2-5).**

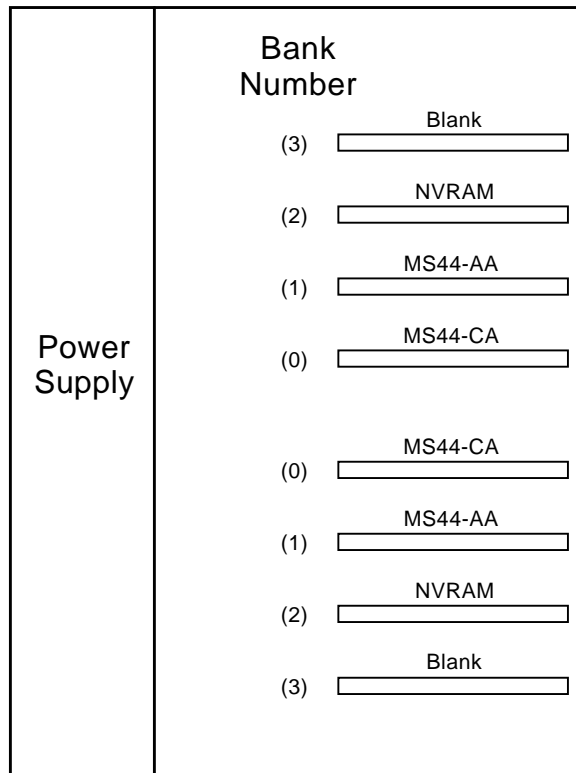
**Figure 2-6 Location of Memory Banks**

In a typical configuration, the DECsystem 5100 contains MS44 memory and NVRAM modules located in the following positions (also see Figure 2-6):

- Bank 0 has two MS44-CAs (32 Mbytes).
- Bank 1 has two MS44-AAs (8 Mbytes).
- Bank 2 has the NVRAM modules.
- Bank 3 is empty.

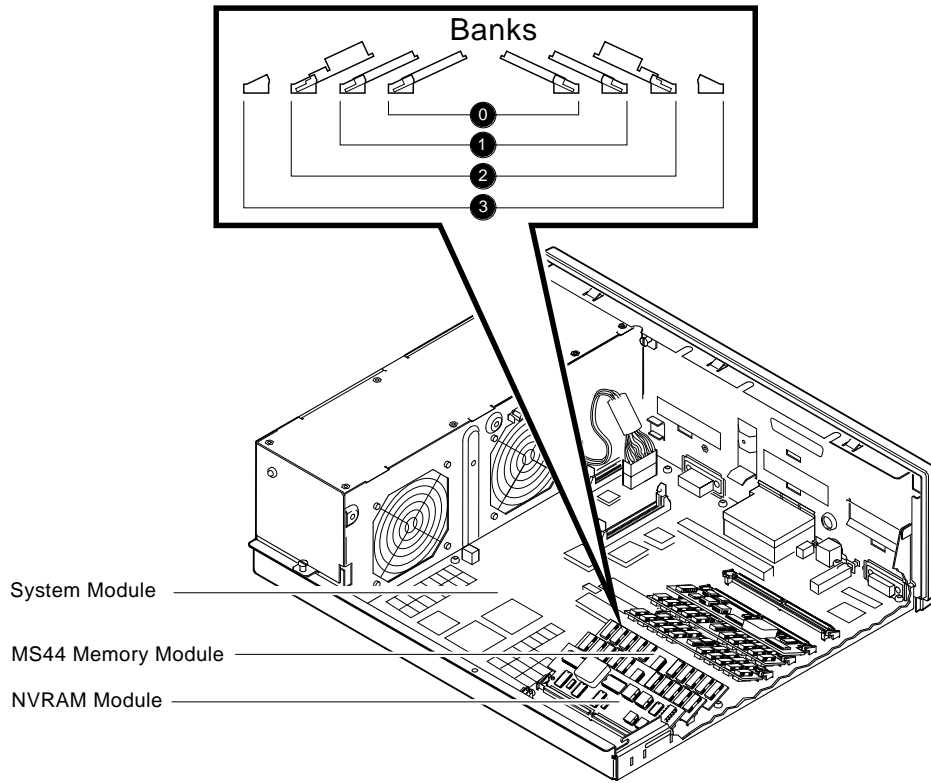
**Figure 2-7 Sample Configuration**

The DECsystem 5100 contains a total of 40 Mbytes of memory and 1 Mbyte of NVRAM. Notice that the two MS44-CA modules are installed in the lowest numbered memory bank (bank 0) before the two MS44-AA modules (bank 1). The NVRAM modules are installed in the next available bank (bank 2).

4. Identify the connectors of the memory bank in which you want to install the NVRAM modules. For bank locations, and memory module and NVRAM module configurations, see Table 2-1, Table 2-2, and Figure 2-7.

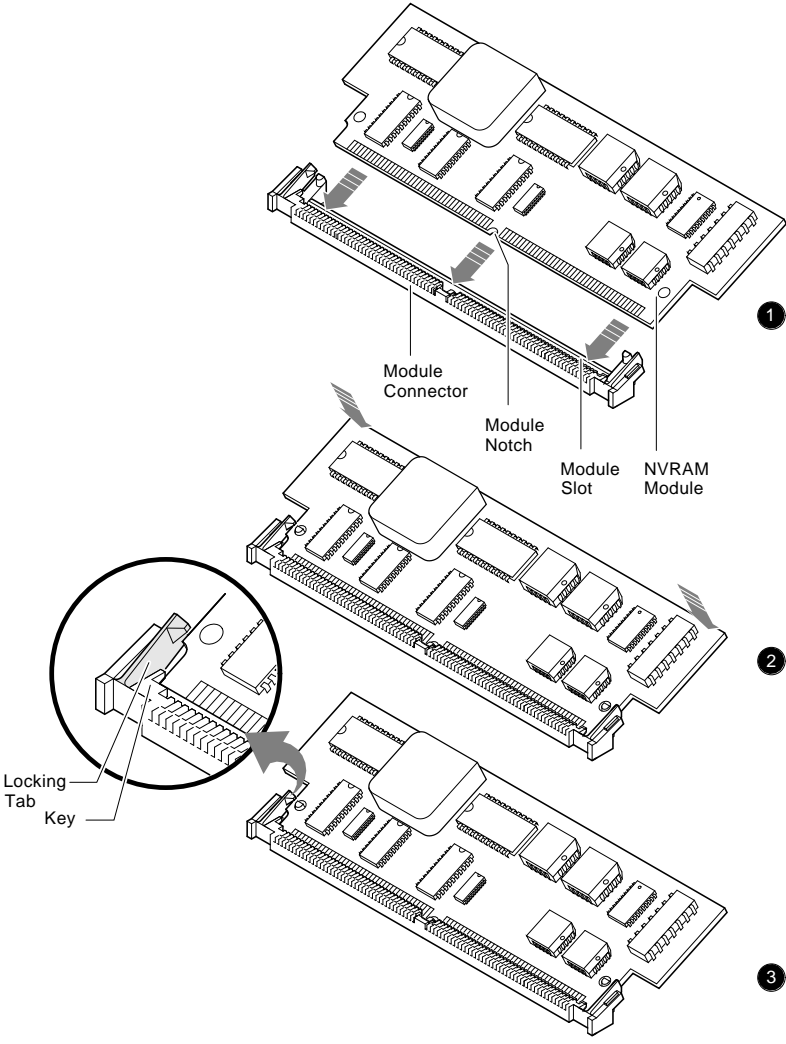
Figure 2-8 NVRAM Module Installation

- ❶ Align the module with the key.
- ❷ Insert the module, with the side containing the bar code label facing up, into the connector on the system module. Gently press down on the module.
- ❸ Verify that the locking tabs are engaged.

5. To install the first NVRAM module, follow the steps shown in Figure 2-8:

**The connectors are keyed so that you can install the NVRAM module with the correct orientation. Do not force the modules into the connectors if the key in the module does not align with the connector.**

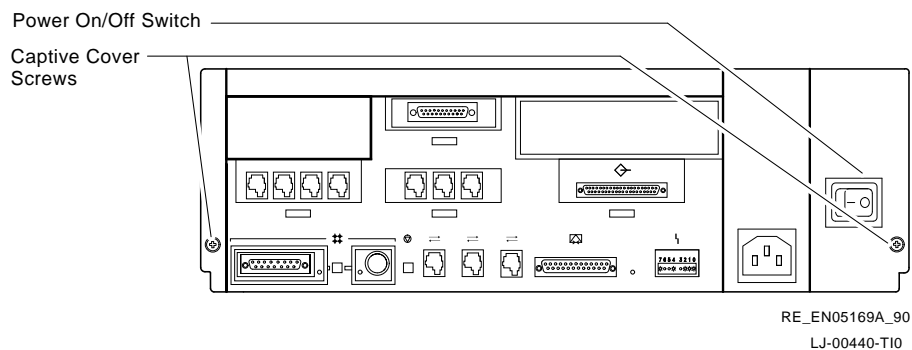
Figure 3-1 Location of On/Off Switch

To run the power-up self-test, turn the system unit's power switch on ( I ). Figure 3-1 shows the location of the system unit on/off switch.
